GELCOAT BLISTERS

A GUIDE TO OSMOSIS REPAIR

Repairing of fibreglass boats following osmosis damage with WEST SYSTEM ® Brand epoxy.

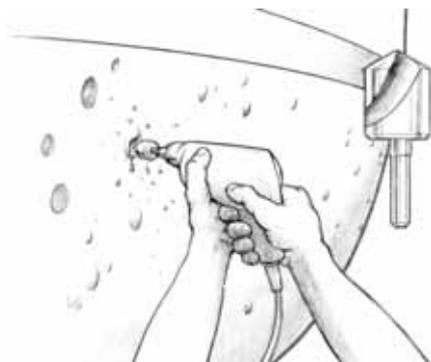
Figure 4.1. A variable speed drill with a countersink bit can be used to open blisters while providing good depth control

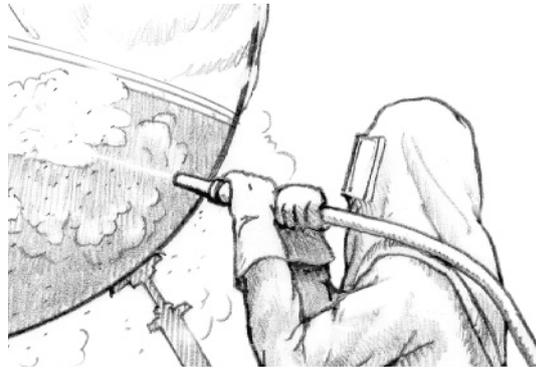
Figure 4.3. Sandblasting is a common method of opening blisters and abrading the hull

This method is also a potential health problem because of the airborne dust generated. Antifouling paint must be removed before sandblasting as failure to do so may result in small particles of paint becoming embedded in the laminate. This may create subsequent bonding problems.

Do not drive gelcoat particles into the softer, underlying laminate nor remove excessive quantities of the laminate. Remove between 90% and 95% of the gelcoat by sandblasting and then complete the process by sanding. After the gelcoat is removed, inspect the laminate for delamination and any further damage; sound the hull for voids.

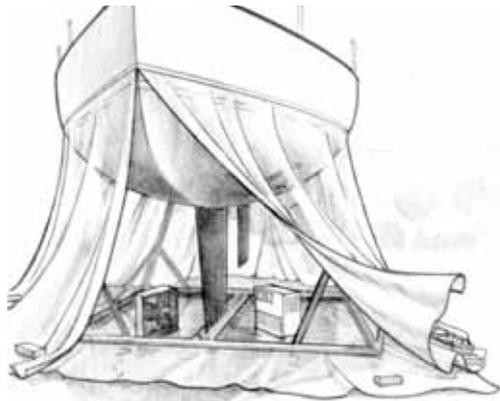
Figure 5.1. Drying the hull can be accelerated by tenting the hull with a plastic skirt taped just above the waterline.

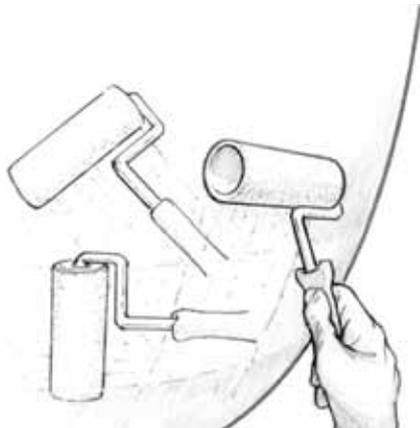
Figure 6.1 Wet out the surface with resin/hardener mix. to avoid sags, allow the wet-out coat to gel before applying fairing compound.

1. Prepare the surface of the hull by abrading any lumps or ridges and removing all dust from the area(s) to be faired, using clean clothes and/or WEST SYSTEM 850 solvent if necessary.
2. Wet out the surface(s) to be faired with a resin/hardener mix and allow this to reach its initial cure or “green stage” to avoid sagging of the fairing compound.

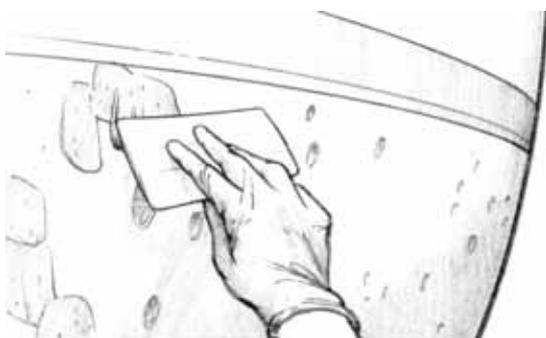
Figure 6.2 Use a squeegee to apply fairing compound, and slightly overfill the area. Shape the mix to blend with the surrounding contour.

3. Prepare a fairing mix with WEST SYSTEM epoxy and either 407 Low Density filler or 410 Microlight filler and blend in filler until it becomes a non-sagging “peanut butter” consistency. **Note:** The thicker the fairing mix, the easier it will be to sand when cured.
4. Trowel the thickened mix into the wetted surface with a plastic squeegee, working it into all voids and depressions.

5. Use the squeegee to smooth the filled epoxy as close as possible to the desired profile to avoid excessive sanding after the mix has cured. It is important to fill the low areas to just above the “fair level” so the fairing compound can be sanded to the required contour after cure.
